Final Report

EXISTING STRUCTURES EVALUATION
Part V: Applications

STANFORD RESEARCH INSTITUTE
Menlo Park, California 94025 - U.S.A.

| 6. REPORT DATE July 1971 | | 7a. TOTAL NO. OF PAGES 112 | 7b. NO. OF REFS 8 |

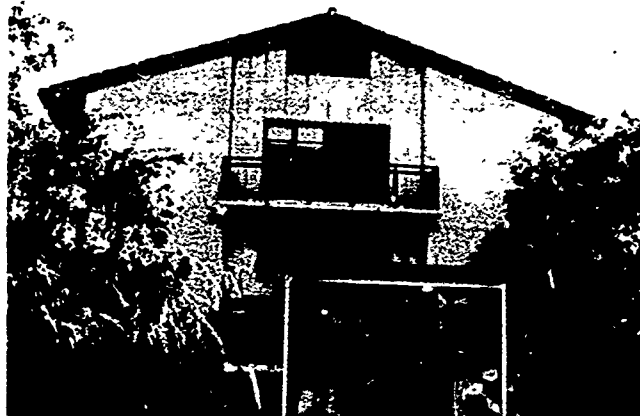
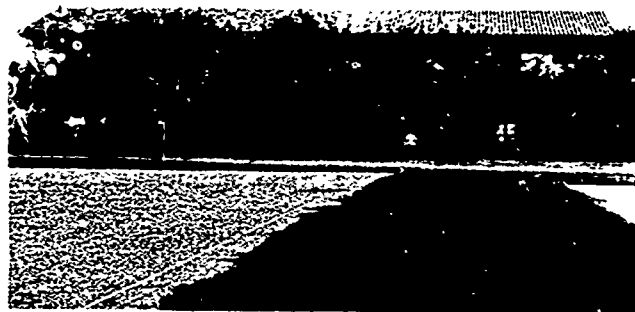
FIGURE 1 PHOTOGRAPHS OF WILBUR HALL #6

Wilbur Hall #6 is a student dormitory located on the campus of Stanford University; it was constructed in 1954. The building consists of three stories with an overall height of about 35 ft and plan dimensions of 41 by 136 ft, which provide an area of about 5,560 sq ft per floor. There is no basement. A photograph of the building is shown in Figure 1.

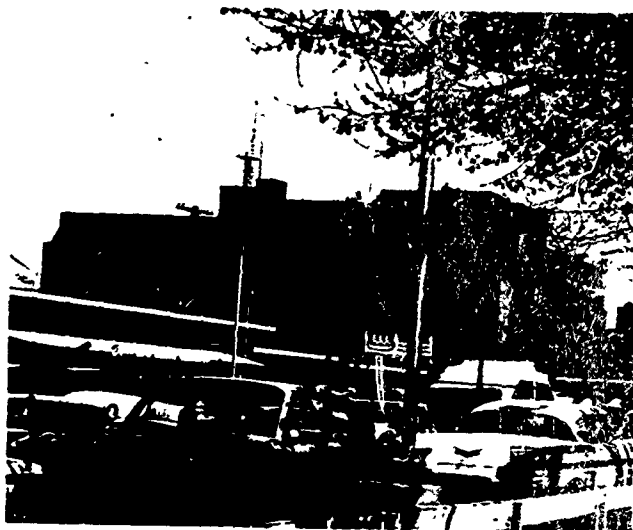
The Montgomery Ward store is located at 14455 Gratiot Avenue, Detroit, Michigan, and was constructed in 1939. The building consists of three stories and an unexposed basement, with a mezzanine between the first and second floors. The overall height of the building is about 49 ft with plan dimensions of 151 ft by 175 ft (avg), which provide an area of about 26,100 sq ft per floor. As noted on Figure 6, the ground floor exterior wall has large show windows on the two sides facing the street, whereas on side B, which is windowless, the first story is shielded by an adjacent structure. The second and third stories have windows in all walls except side B, but the percent openings on side C is much less than on sides A and D. The mezzanine is windowless and extends about 10 ft into the first floor area.

The exterior walls are constructed of a 4-in. brick facing backed with an 8-in. structural clay tile, with a decorative stone treatment on sides A and D. The walls are unreinforced, and the 8-in. clay tile is inset in the structural frame, while the brick facing is continuous over the columns and beams. The first floor exterior wall below the mezzanine floor on sides A and D consists of 3-ft wide wall elements backed by columns with the 15-ft wide windows between. The interior partitions in the basement are 8-in. concrete or unreinforced concrete block and on all other floors are 4-in. timber studwall.

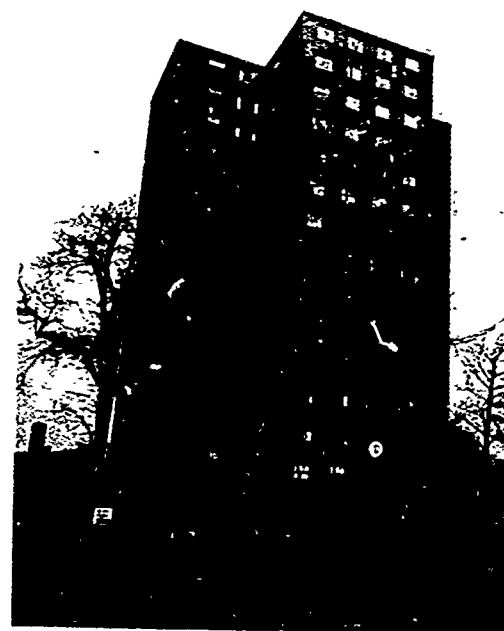
FIGURE 8 PHOTOGRAPHS AND PLOT PLAN OF
DETROIT HOUSING COMMISSION
EDWARD J. JEFFERIES HOMES

Field Survey Data. During the on-site survey, the exterior walls were classified as concrete panel walls with masonry veneer for the ground floor, and tile panel walls with masonry veneer for all upper floors. Even though the walls were described as panel walls, it was stated in the field survey that the observed and estimated support conditions were that the tile was inset in the frame and the brick facing was continuous over the supports. Because of this apparent anomaly, it was decided to analyze the unreinforced masonry walls on the upper floors for both arching and nonarching supports.

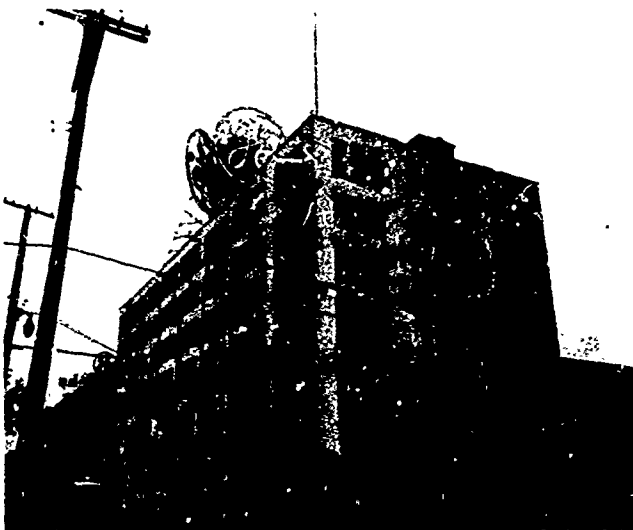
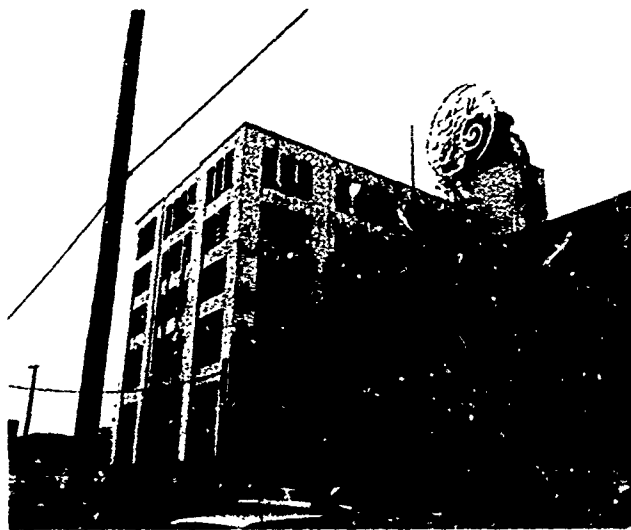
The GE Service Building is located at 700 Antoinette, Detroit, Michigan, and was constructed in 1924 for use as a warehouse. The building consists of five stories, with an overall height of about 81 ft and plan dimensions of 76 by 201 ft, which provide an area of about 15,200 sq ft per floor. There is no basement. As noted on Figure 10, the exterior walls on the first four floors have large window areas, e.g., the windows on the second floor of side B comprise 51 percent of the wall area. The fourth and fifth floors have been converted to office use.

The structural framing is of conventional reinforced concrete flat slab construction with column capitals and drop panels. The reinforced
